## **Testreport**

### **Storage container for critical vehicle batteries based on LP906 and P911**

**DUT : DryFire Storage**

**Test Lab : Fraunhofer HHI /  
VoltaLabs GmbH**

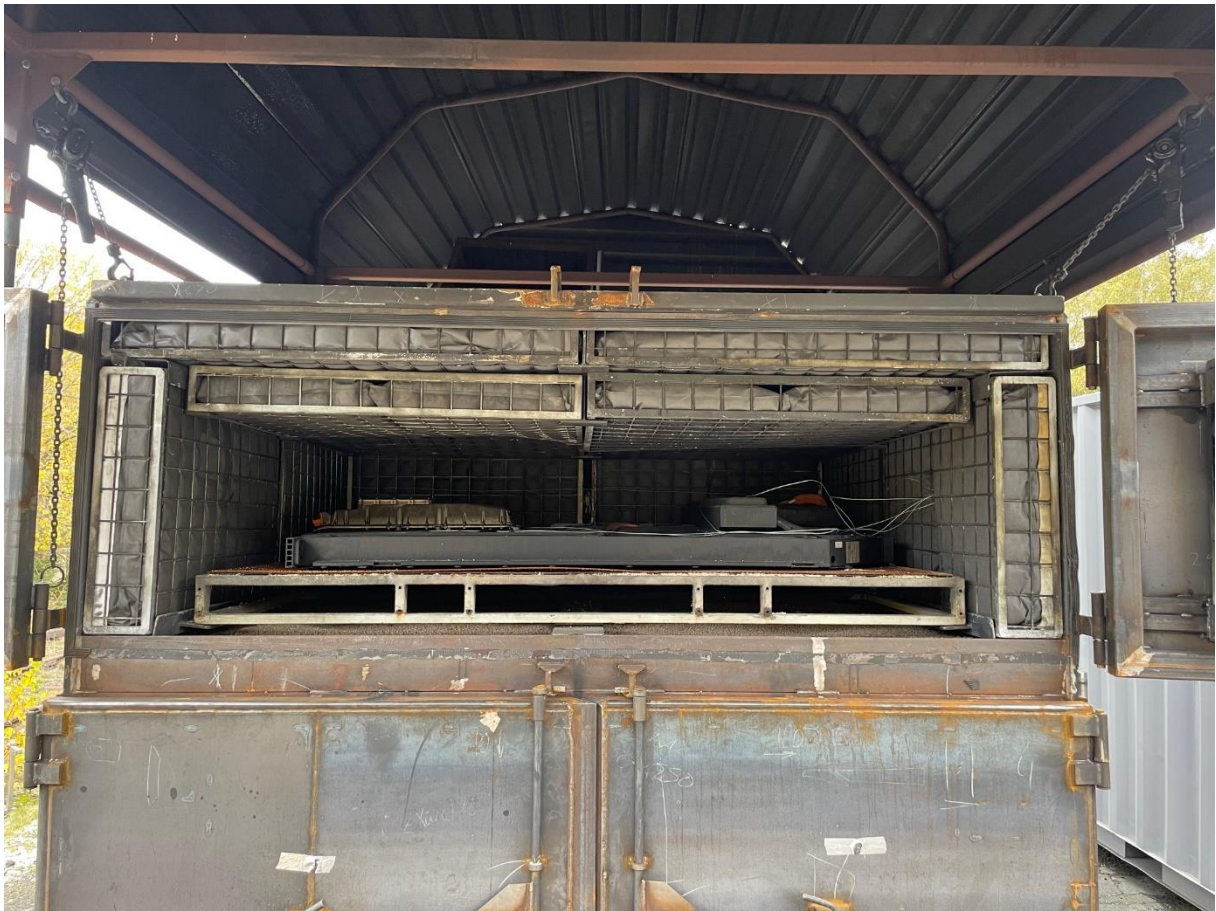
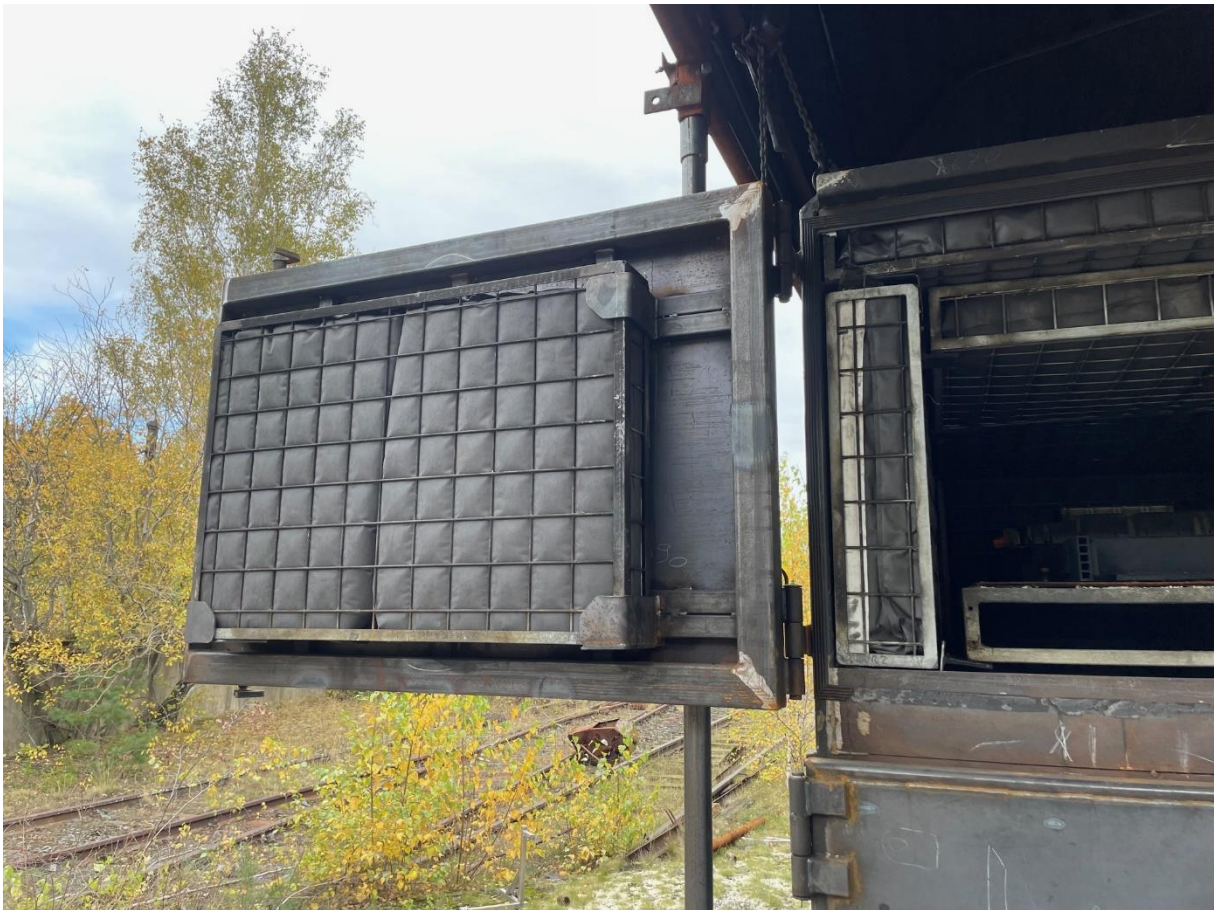
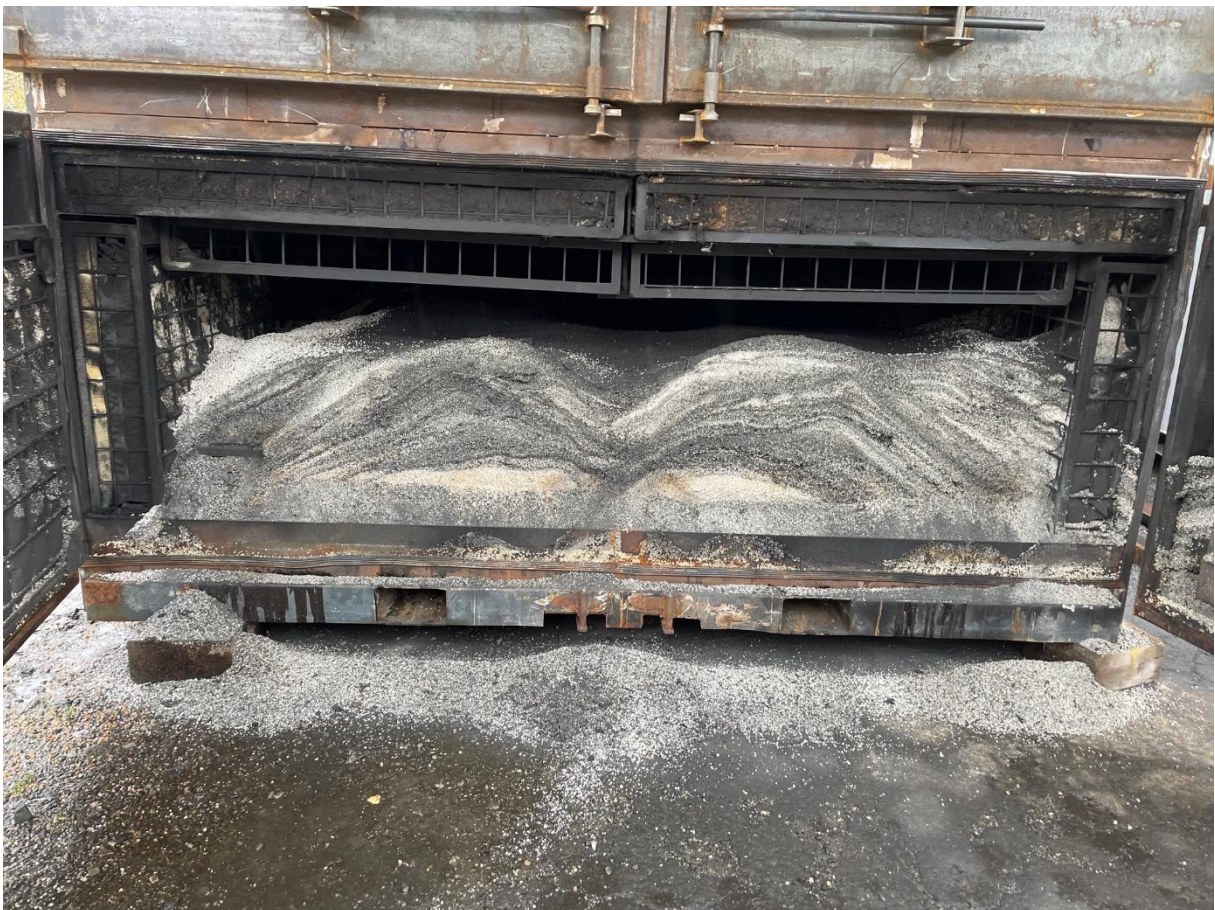
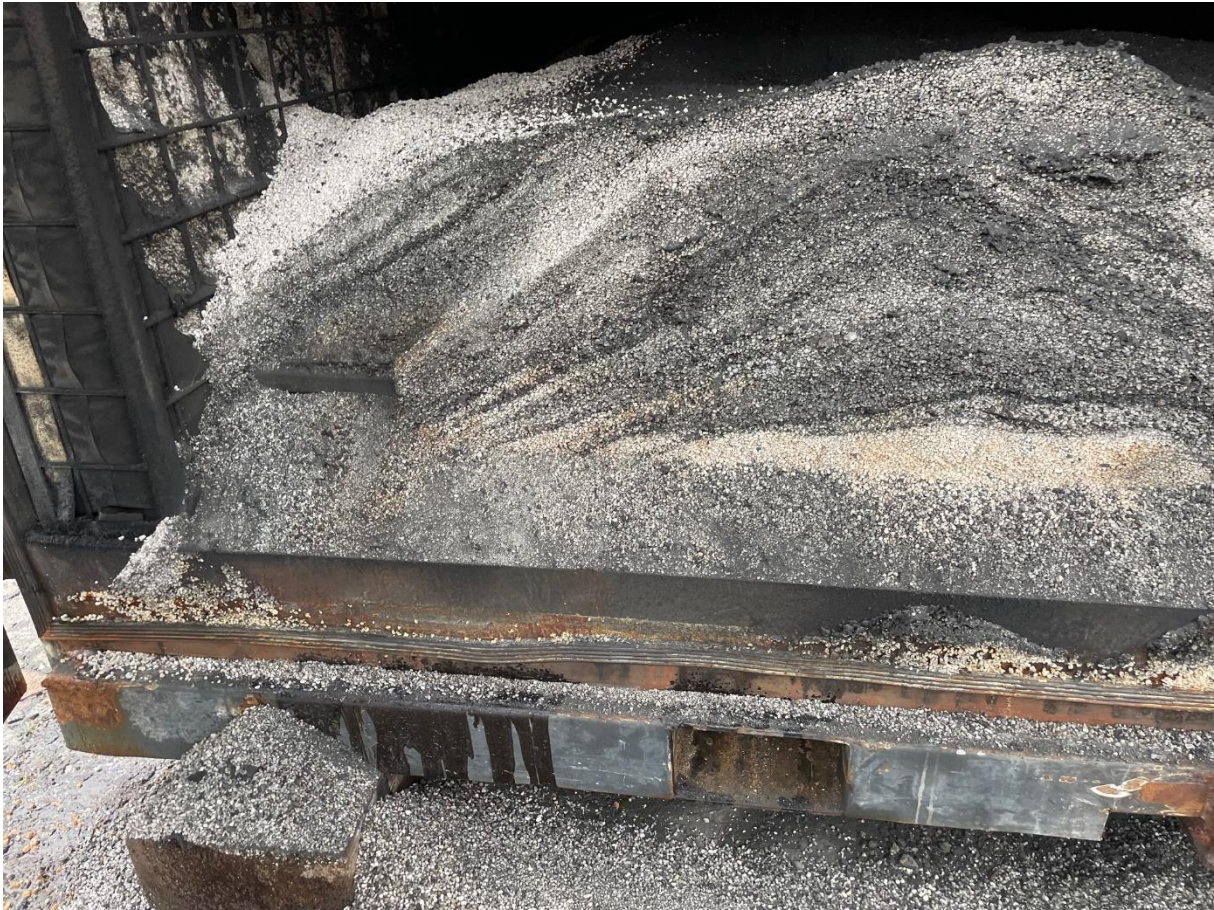
The pictures hereunder show the status of the battery at the end of the test.

- a. After inspecting the container at the end of the test, the container was completely intact.
